October 5, 2011

ISSUED FOR USE
EBA FILE: W14101068.037

Subject: Water Storage Pond Dam – 2011 Physical Observation Report
Minto Mine, YT

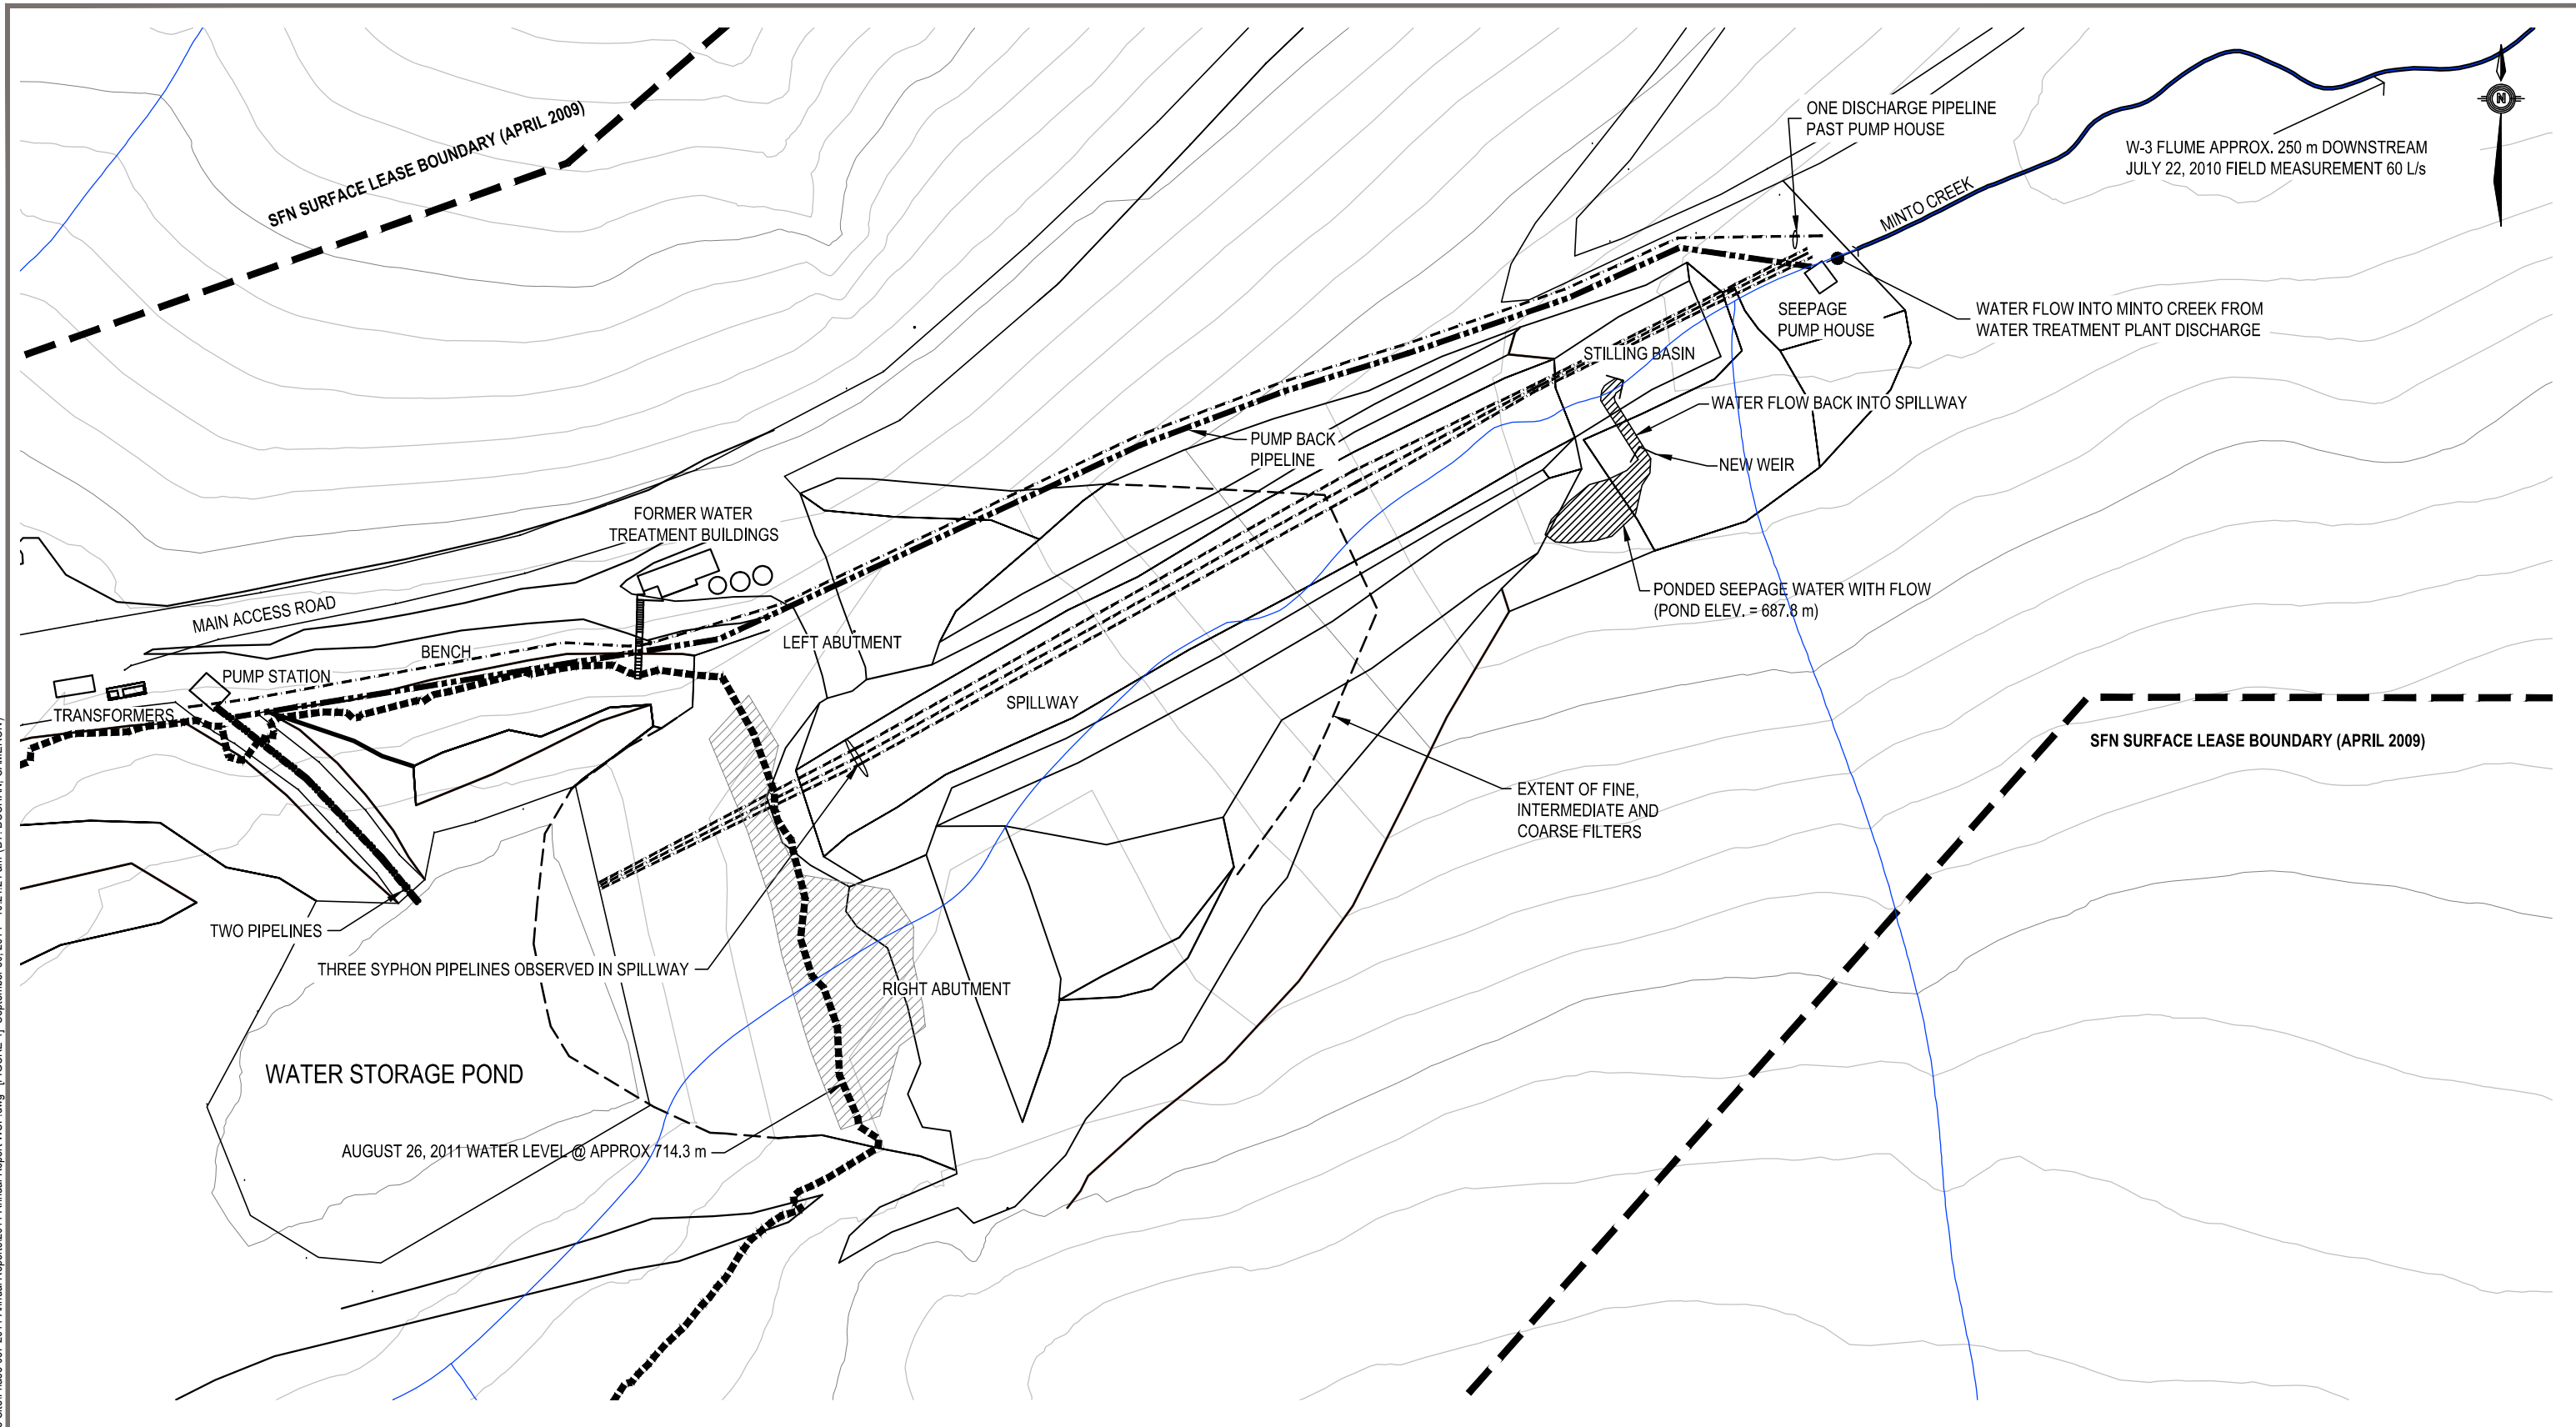
- The left upstream abutment at the general fill soil/Zone 1 fill contact did not show any signs of settlement or movement. The general fill soil was used in the construction of the pad for the water treatment buildings and does not form a part of the actual dam. A minor erosion channel was noted in the general fill in this area that resulted from surface water flow from the main access road as noted in Figure 1. This erosion channel does not affect the actual Zone 1 dam fill.

- The right downstream abutment at the natural soil and rock fill contact appears consistent with original construction and did not show any signs of instability. As noted in the 2008, 2009 and 2010 inspection reports, ponded seepage water was observed southwest of the spillway as depicted in Figure 1 and Photo 6. This water flows back into the spillway as presented in Figure 1. Water flow could not be heard within the spillway north of the ponded water.

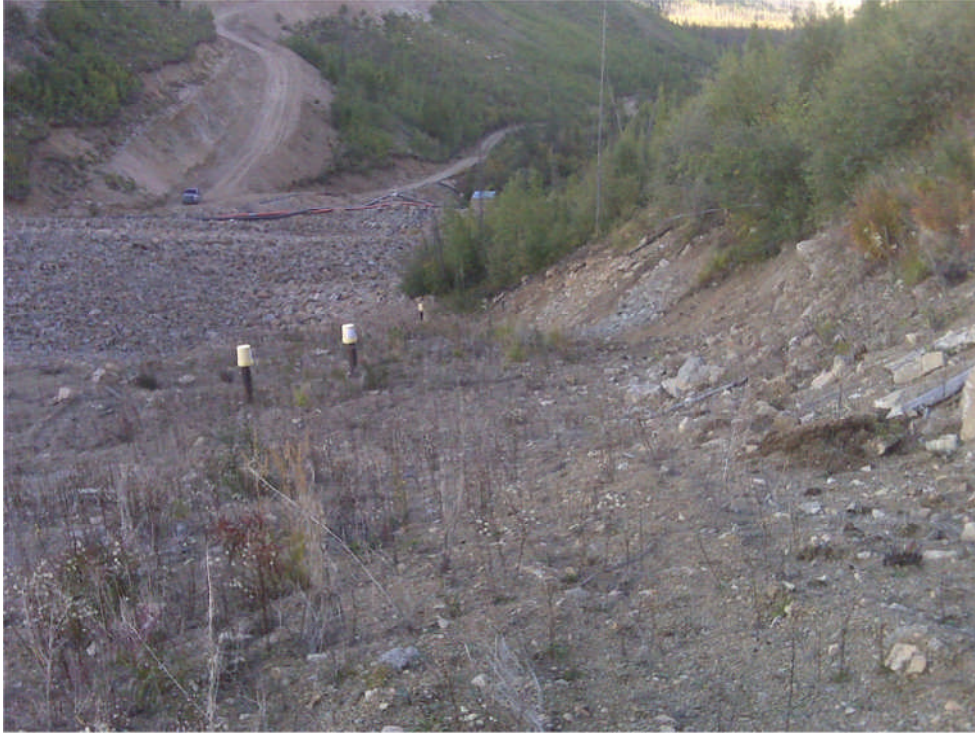
Photo 3

- The downstream sideslope of the dam including the spillway appears consistent with original construction and did not show any signs of instability (settlement, bulging or slumping). Photos 3, 4 and 5 show the downstream sideslope of the dam, including the left and right abutments and the spillway.

Looking at the right downstream slope. (August 26, 2011)

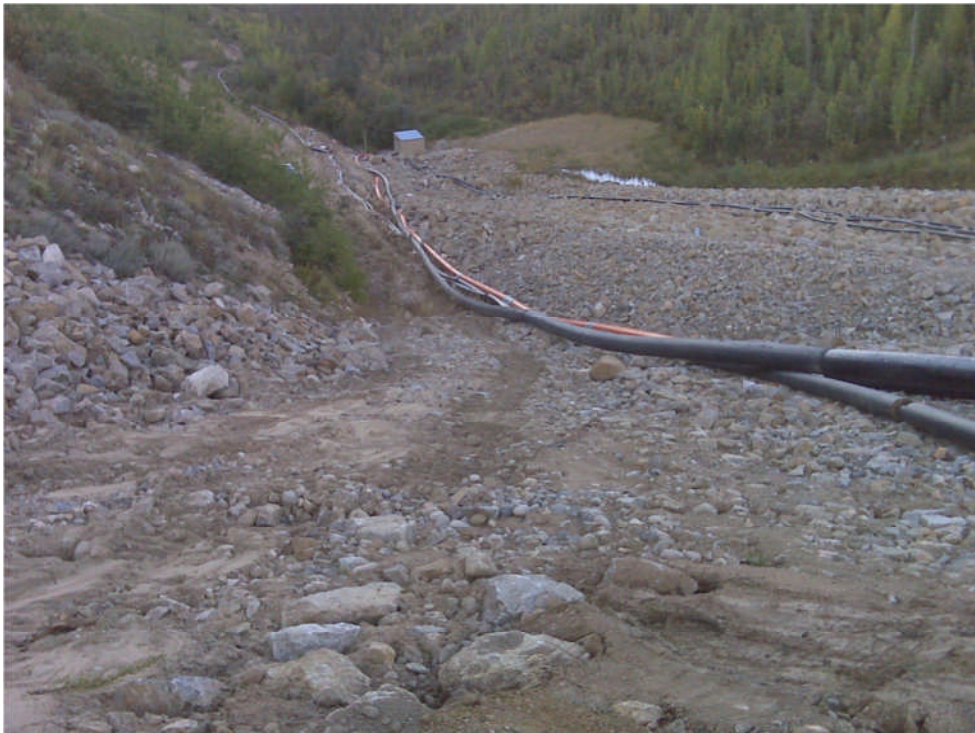
Photo 4

Looking at the left downstream slope. (August 26, 2011)

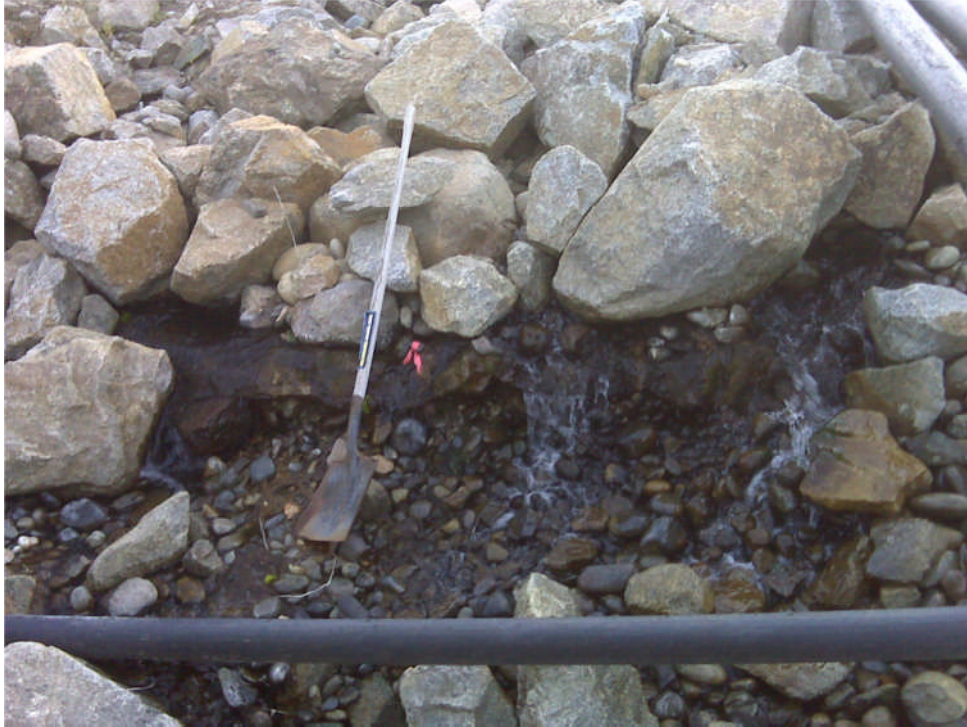
Photo 7

- The stilling basin appears to be in satisfactory condition and functioning properly as it was full of water which overflowed into the gravels upstream of the seepage pump house (Photo 9). The observed seepage water was clear with no turbidity or suspended solids. Accumulations of eroded sand and silt were also not observed.

Seepage at the stilling basin toe upstream of seepage pump house. (August 26, 2011)

- Minto should continue to complete regular inspections of the dam, and specifically note the clarity of the seepage at the noted seepage pond at the toe of the right abutment and flow exiting the stilling basin. Written records of these inspections should be kept by Minto staff.

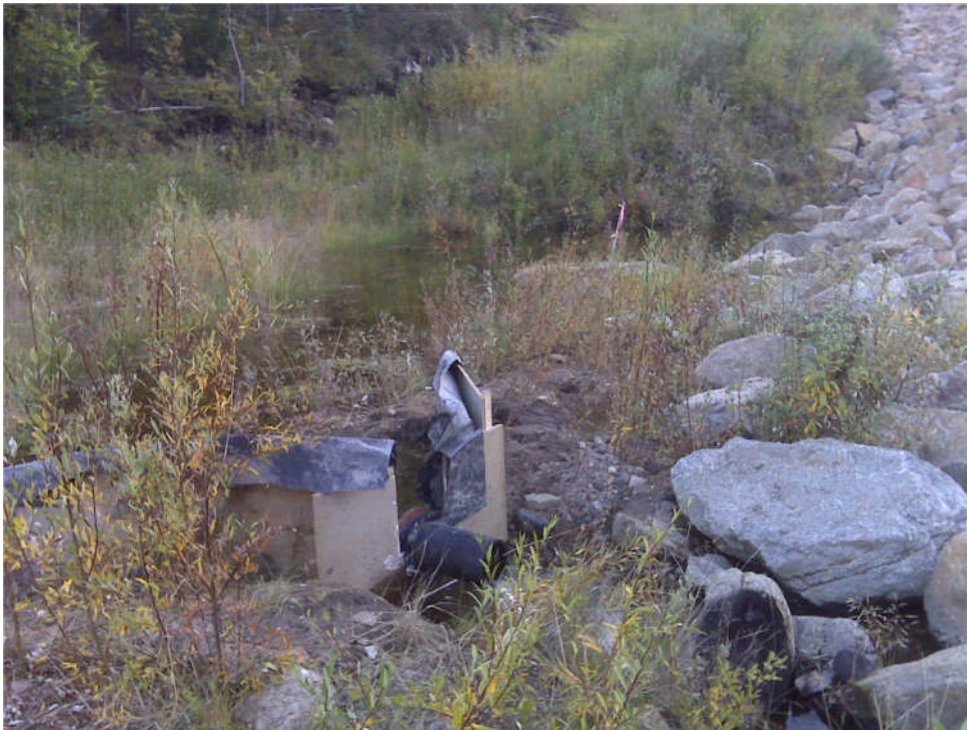
Photo 8

- At the time of this site visit, EBA noted that Minto had constructed a weir along the discharge side of the ponded seepage water to monitor the amount of seepage coming from the dam toe (Photo 11). The estimated flow rate through the weir was 5 L/s.

Weir at the ponded seepage water near the WSP dam toe. (September 14, 2010)

- Minto should continue to measure the actual seepage rate through the weir for the ponded seepage water next to the dam toe and compare it to the flow at the W-3 flume. To determine how much water is being collected at the seepage pump house at the dam toe and being pumped back to the Water Storage Pond, it is suggested that the seepage pump be periodically shut-off and the flow rate recorded at the W-3 monitoring station after the flow rate has stopped increasing in response to the cessation of pumping. Once the maximum flow rate has been recorded the pumping could be started again. This should be conducted once a month during summer months with surveys of the WSP level taken each time.
