ABANDONED MINES

Clinton Creek Mine BACKGROUND

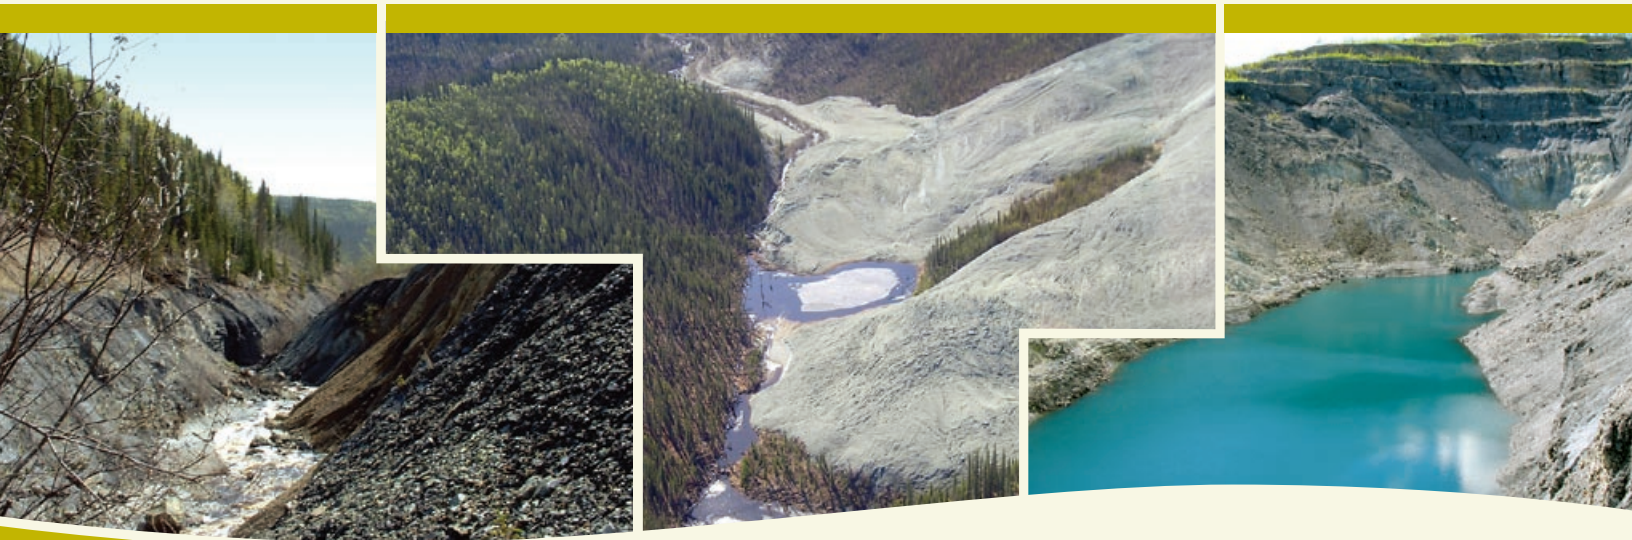
Photos from left to right: waste rock to the right over Clinton Creek; tailings over Wolverine Creek and; Porcupine Pit

In 1974, 60 million tonnes of the Clinton Creek waste rock pile broke and resulted in a slide that blocked both the valley and the creek, causing the water to build up and form a lake. This body of water, Hudgeon Lake, now covers over 115 hectares about the same size as 150 football fields and in places is up to 25 metres deep.

Clinton Creek and Wolverine Creek have eroded both the tailings piles and waste rock pile. This drastically altered the fish habitat in upper Clinton Creek and Wolverine Creek.

During operation, the mill emptied 10 million tonnes of tailings onto the slope above the Wolverine Creek valley. The tailings have now slid down the slope and partially blocked the water flow of Wolverine Creek. This has resulted in the creation of two small ponds.
