# ABANDONED MINES

## Clinton Creek Mine

### TIMELINE

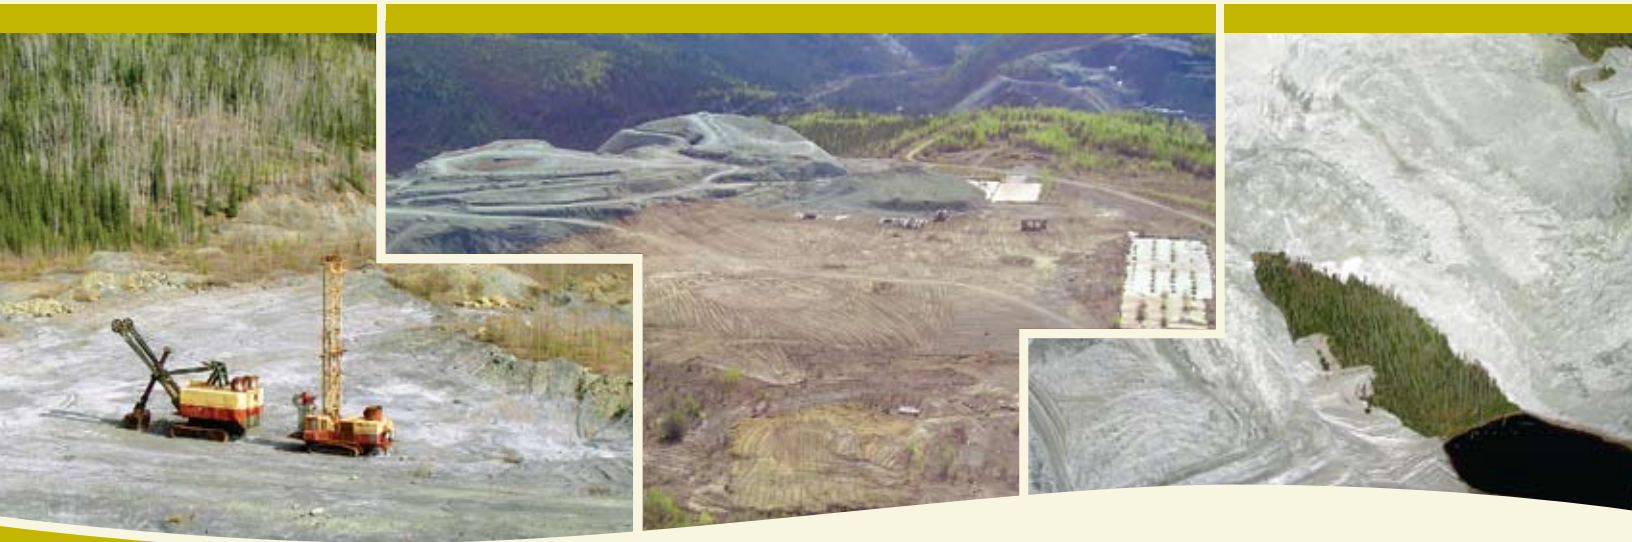
*Photos from left to right: historical shovel and drill still at site; mill site as it looks today and; tailings over Wolverine Creek*

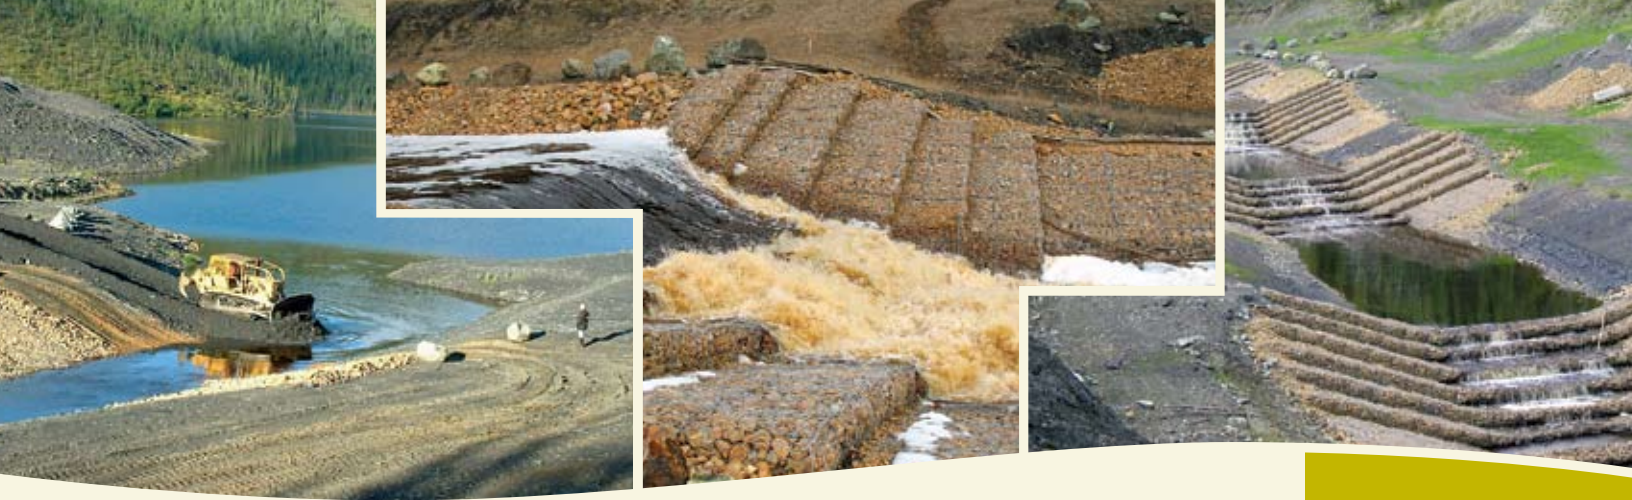
*Photos from left to right: preparation for gabion baskets; gabion structure during spring run off and; gabion basket structures now in place*

Canada begins work to stabilize the channel under the emergency section of the *Waters Act*. As previous stabilization is not successful, Canada implements an initial phase of a channel stabilization program with the installation of gabion structures.

Government of Yukon (Yukon) takes over management of site under devolution and Canada retains financial responsibility. As part of the Phase II creek stabilization plan, additional gabion structures are installed to reduce the erosion of the waste rock pile. Site monitoring continues.

Yukon begins to remove physical hazards on site. Gabion construction for channel stabilization is completed.

Environmental site monitoring continues and major repairs to the gabion baskets are made due to damage from extreme water flows. Scientific and technical studies are conducted in preparation for a long-term management plan.
