**YESAA NON Triggered - YG LAND APPLICATION REPORT  
Updated to September 21, 2011**

Application Number	2010-1401
Name	<b>JOSEPH &amp; MARIE-ANNE CODERRE</b>
Application Type	Water Lot
Date Review Completed	September 8, 2011
DO Application Number (YESAB)	2010-0234 then closed work already done

**APPLICANT'S REASON FOR APPLICATION AND SIZE:** Marsh Lake inundation (a few years ago) ate up the root system of several large trees that protected the shore front of Lot 16 every spring a large chunk of shore "falls". We intend to make a "ramp" to the shore to stop this fast erosion.

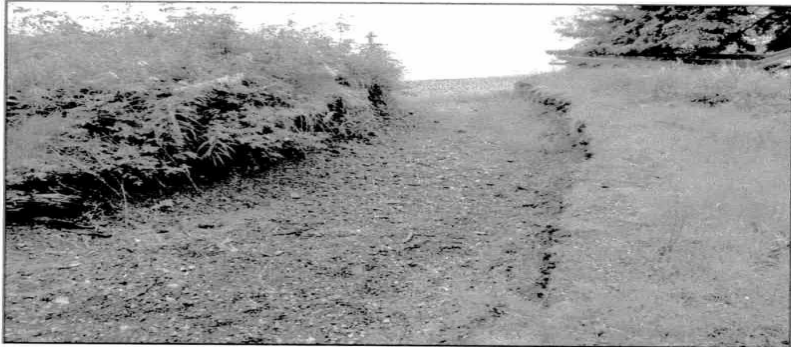
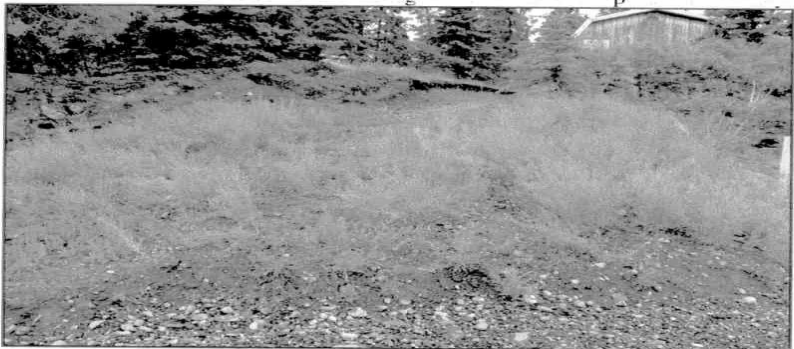
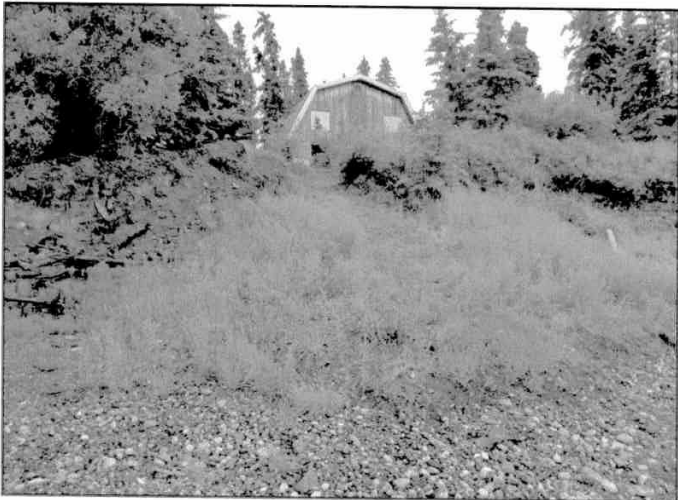
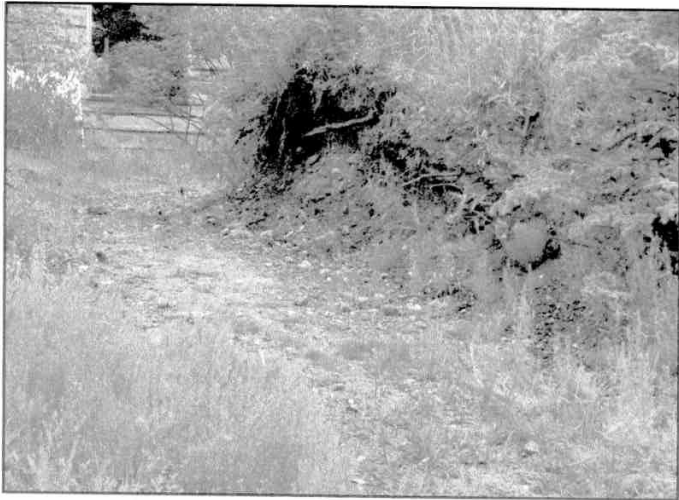
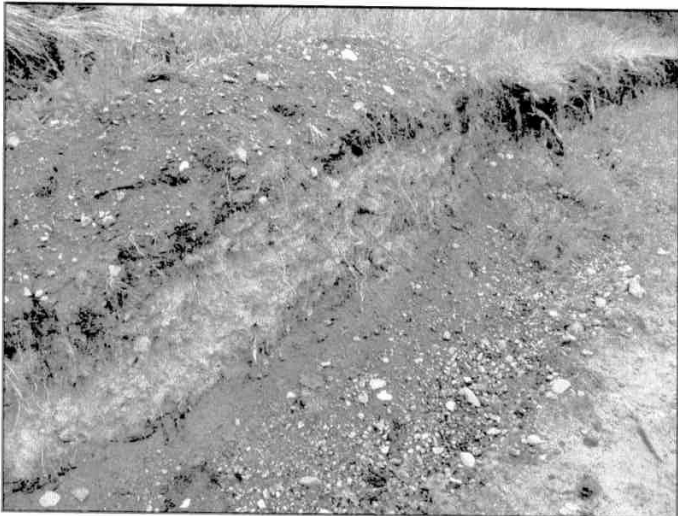
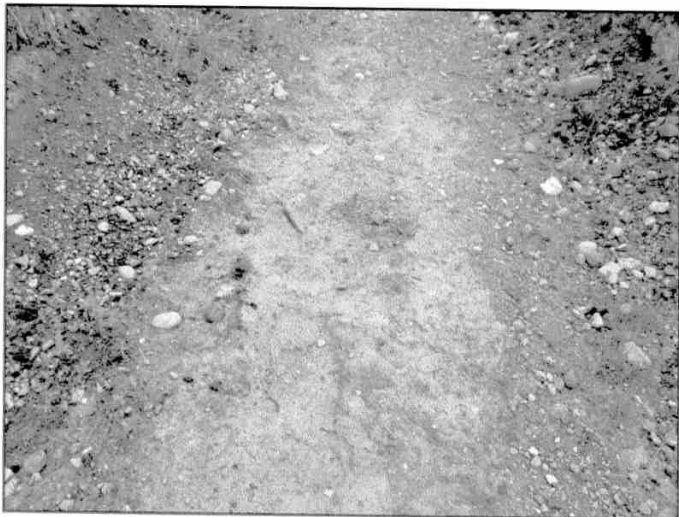
<p><b>Natural Resources Officer INSPECTION COMMENTS – Southern Lakes</b> <i>Inspection requested in snow free conditions Date Received: June 21, 2011</i> <b>Existing Improvements:</b> Access has been cut into the waterfront reserve</p> <p><b>Soil:</b> The cut access is within silty loam with some beach sands and gravel, waterfront reserve is beach sand and gravel</p> <p><b>Vegetation Cover:</b> Access is revegetating partially with grasses and shrubs surrounding vegetation mainly mature riparian spruce</p> <p><b>Terrain:</b> Northeast aspect with a 5% slope</p> <p><b>Water bodies:</b> Marsh Lake adjacent</p> <p><b>Exposure:</b></p> <p><b>Erosion or possible permafrost:</b> Erosion possible in high water years</p> <p><b>Access Roads:</b> Existing access from Nolan Road through Lot 16 to start of cut access</p> <p><b>Suitable for Building foundation:</b> Not suitable</p> <p><b>Suitable for Septic:</b> Not suitable</p> <p><b>Distance to Water Supply:</b> Marsh Lake</p> <p><b>Subject to Flooding:</b> Yes, in high water years</p> <p><b>Environmentally Sensitive Areas:</b> Lake shore riparian zone</p> <p><b>General Comments:</b> There has been no further work completed since the last inspection. However some of the sand gravels placed within the waterfront reserve have washed away into Marsh Lake since last inspection of August 12, 2010. the rest of the access within the waterfront reserve has begun to re-vegetate with grasses and shrubs as shown in the attached photos. If further work is authorized on the access than it is recommended only coarse gravels are used to prevent further disturbance of lake shore causing further sedimentation of Marsh Lake. The banks on both sides of the 2 metre wide access have been undercut and will continue to erode over time it is recommended that the banks sides of the access be sloped and armoured with gravel and rock to prevent any further erosion As the vegetative layer of the shoreline has been removed trees surrounding the access have had their roots disturbed and now are in danger of falling in strong winds along the waterfront and into neighbouring properties, it is recommended that mitigative measures be taken to prevent further disturbance of any tree rooting structures. This access will require mitigative measures completed to prevent erosional run-off into Marsh Lake.</p>

- 1) The applicant's unauthorized use of Crown Lands will not be permitted after the fact.
- 2) The applicant is required to remediate the land, including backfilling ramp and returning land to original state, based on direction from DFO & CSI.
